Pebble Steel Vibration Motor Replacement

This is a guide to replace the vibration motor in a Pebble Steel Smartwatch.

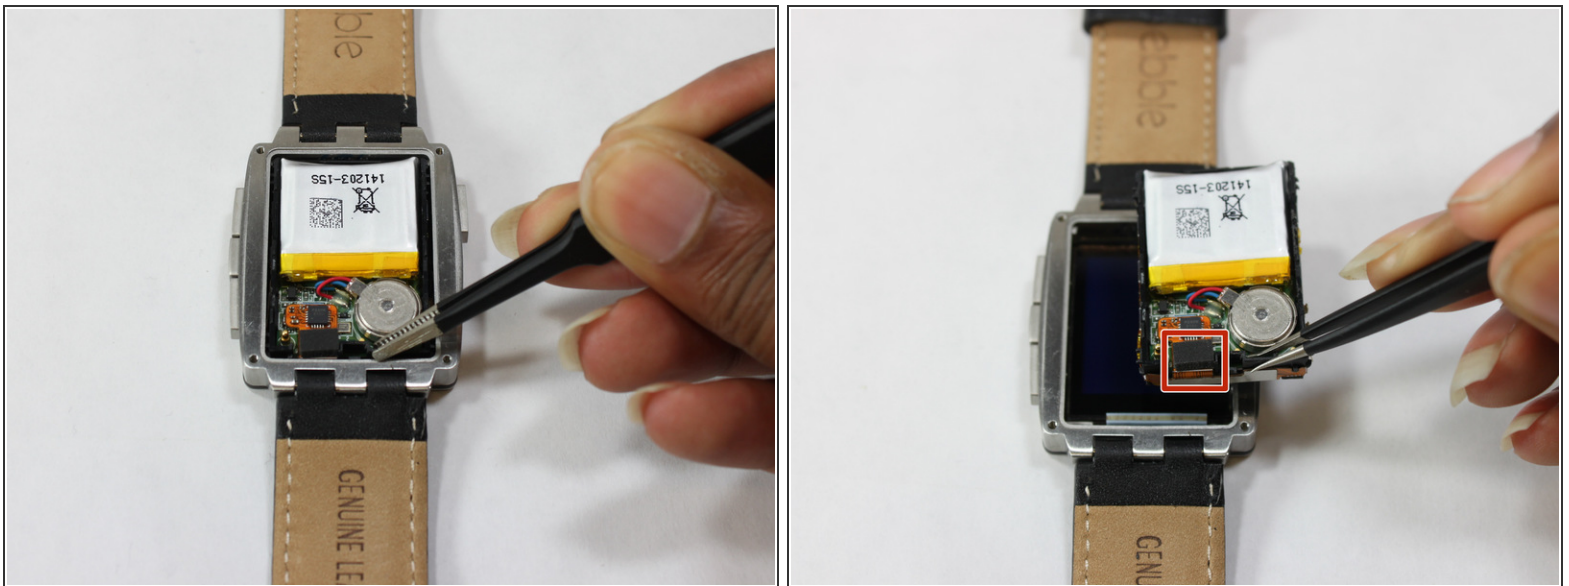
Step 2

- Use a pair of tweezers to grab onto the black plastic frame and remove the internal hardware.
- ⓘ Adhesive on the back side of the battery holds the internal components to the front case.
- Use tweezers or a plastic opening tool to disconnect the ribbon cable from the motherboard.
